# Little Conestoga Creek

## Watershed Assessment and Restoration Plan

January 2003

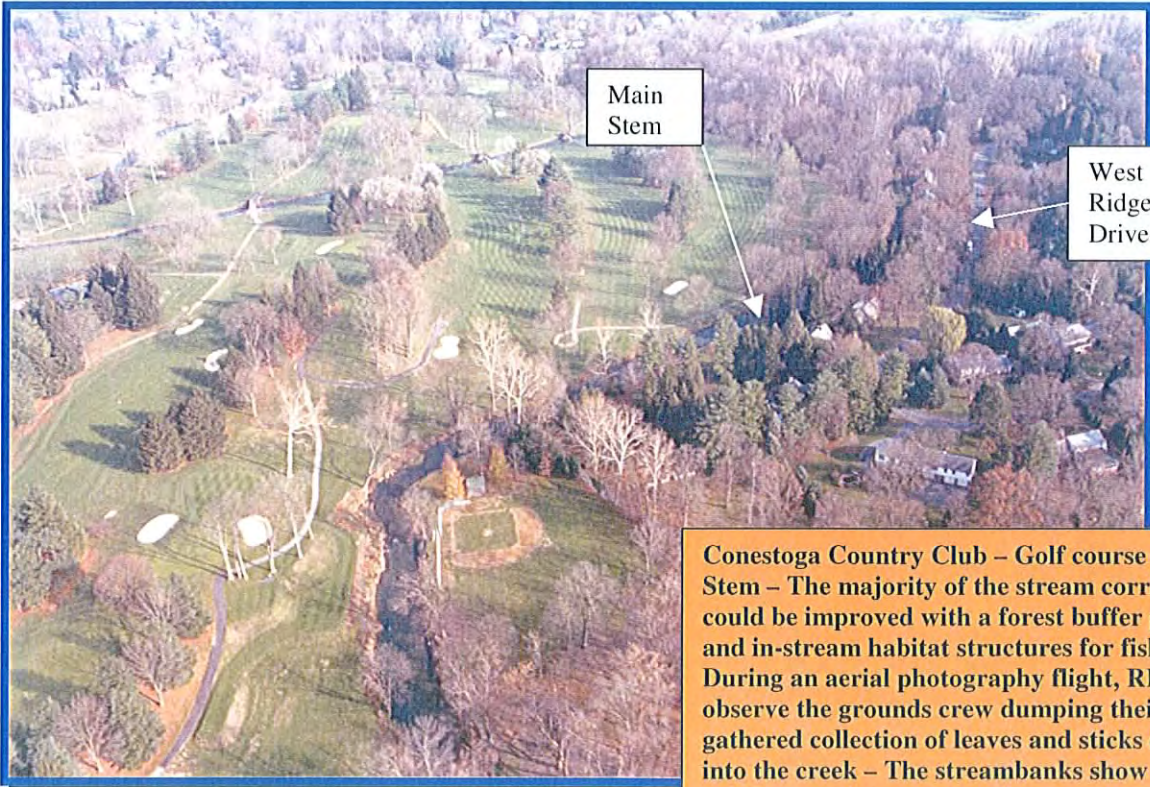
Conestoga Country Club – Golf course on Main Stem – The majority of the stream corridor could be improved with a forest buffer planting and in-stream habitat structures for fish – During an aerial photography flight, RETTEW observe the grounds crew dumping their gathered collection of leaves and sticks directly into the creek – The streambanks show signs of routine mowing and spraying

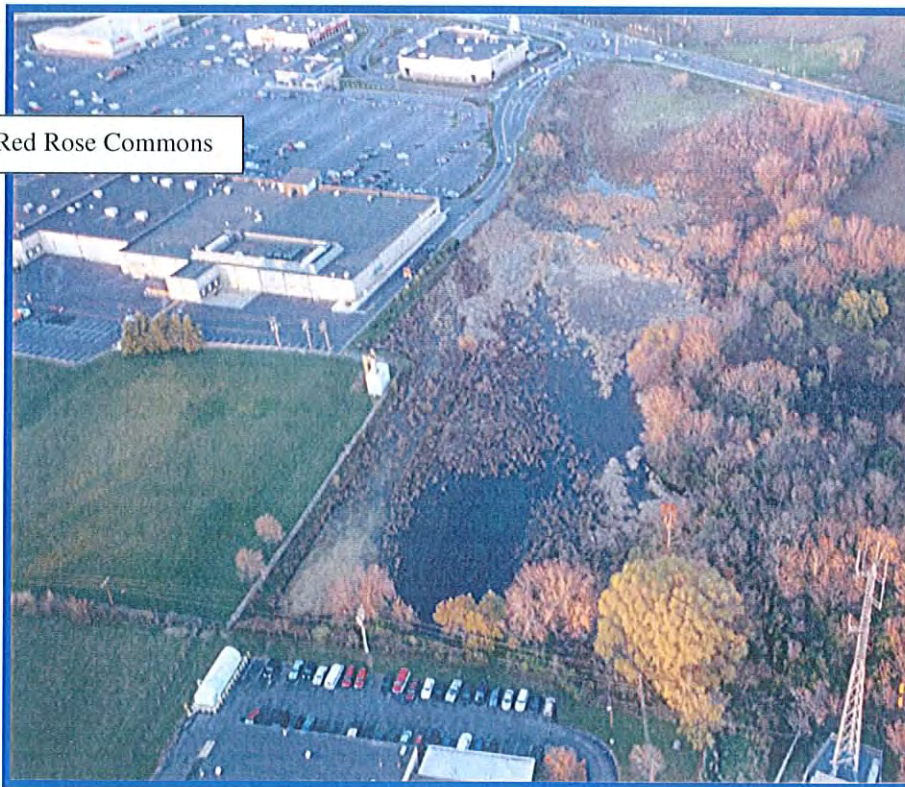
A view of Dillerville Swamp and Red Rose Commons – See plans for spraying and controlling invasive Purple loosestrife in “Completed Restoration Projects” chapter of this report for further details – Dillerville Swamp is now but a fraction of the once incredibly diverse wetland habitat it once was – Franklin and Marshall College had in the past completed extensive flora investigations within the swamp and had identified several rare, threatened and endangered plant species – Recent investigations indicate a loss of these plant species – A unique opportunity exists for restoring the original plant community

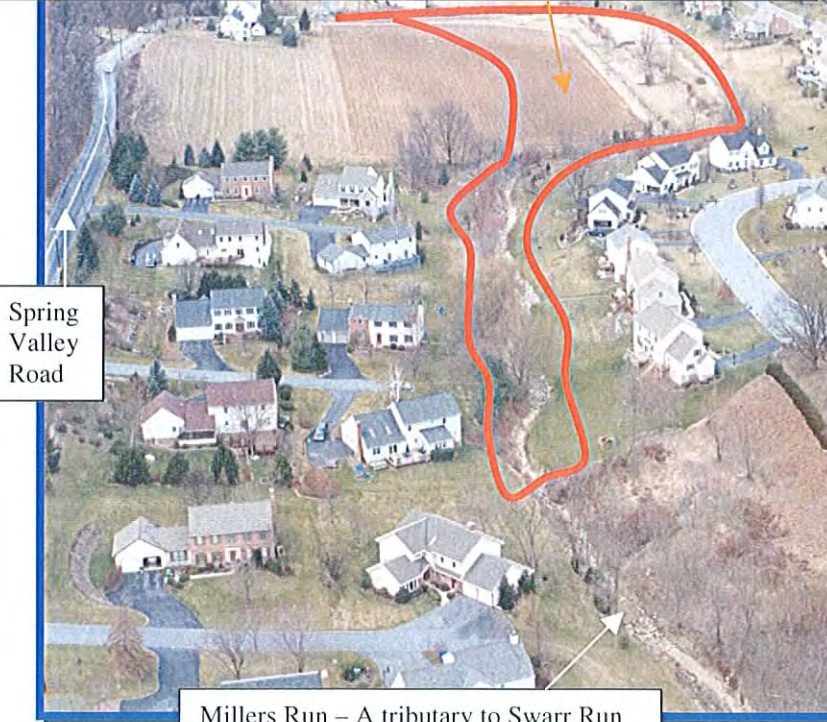
Headwaters of Swarr Run – continuation of previous photograph

Restoration plans being developed at this time for this outlined area

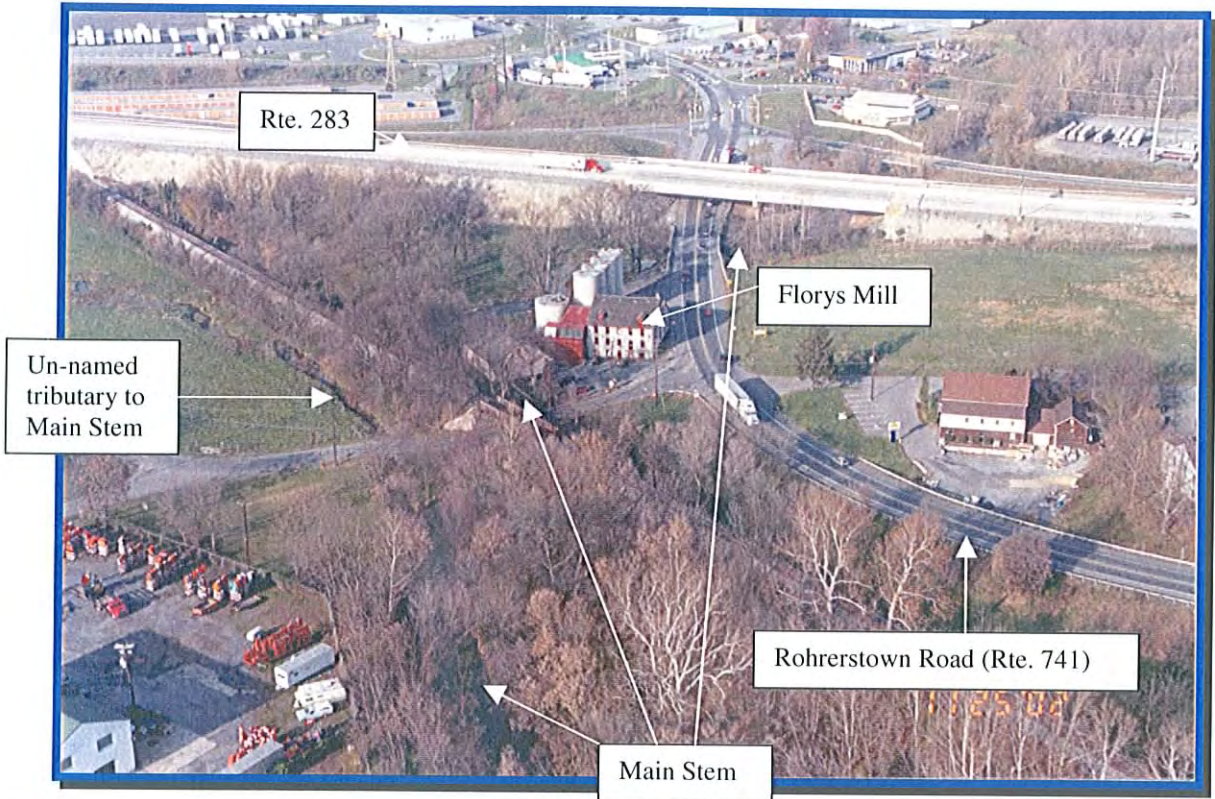
Site of future improvement work funded by received “Growing Greener” grant – This section of Millers Run as well as downstream reaches are severely eroded due to stormwater erosion – Much of the area was developed prior to Lancaster County adopting a stormwater management ordinance – Retrofitting stormwater management facilities, stream bank erosion repairs and forest buffer installations are needed throughout much of this sub-watershed

Florys Mill area – Photograph of same un-named tributary pictured above

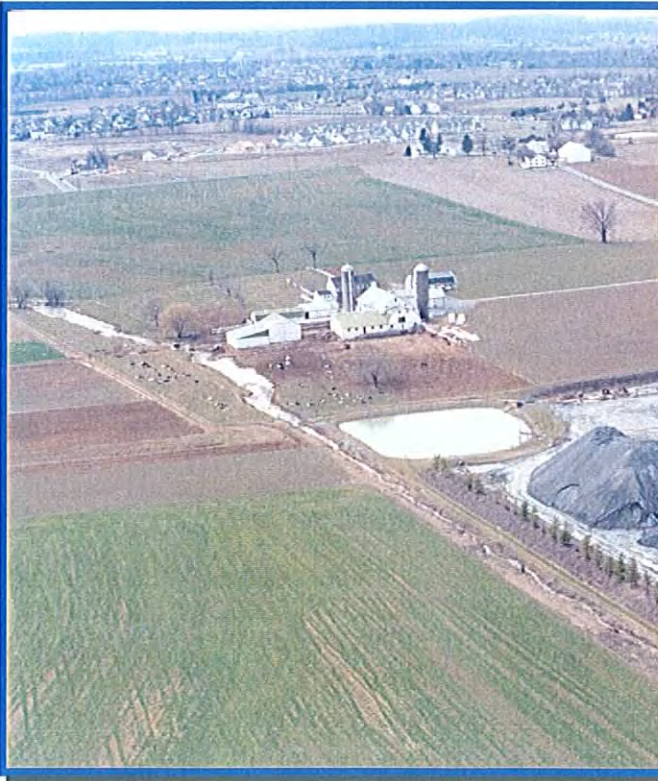
A view of an Amish farm and Rohrer's Quarry at the headwaters of Bachman Run's west branch - The farm is a source of nutrients and sediment mainly through the barnyard area - The quarry is currently in the midst of upgrading their sediment basin and handling of pumped water from the quarry pit to allow for a more consistent flow to the stream rather than periodic surges due to pumps turning on and off

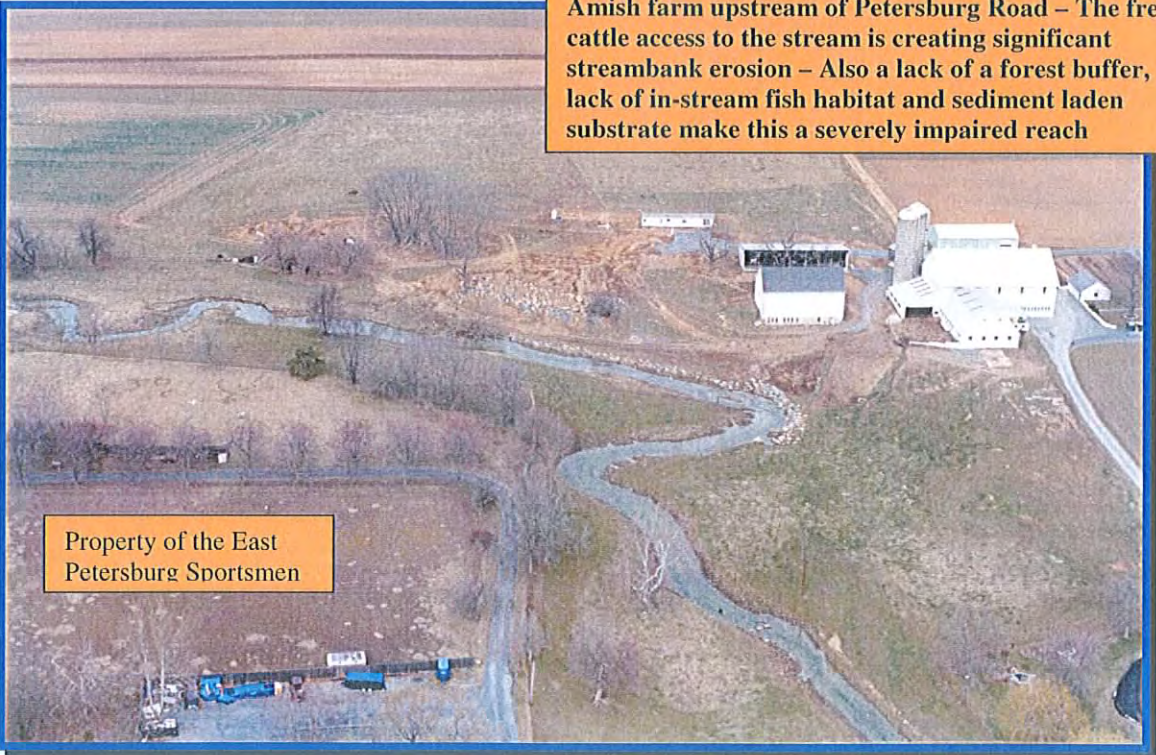
**Amish farm upstream of Petersburg Road – The free cattle access to the stream is creating significant streambank erosion – Also a lack of a forest buffer, lack of in-stream fish habitat and sediment laden substrate make this a severely impaired reach**

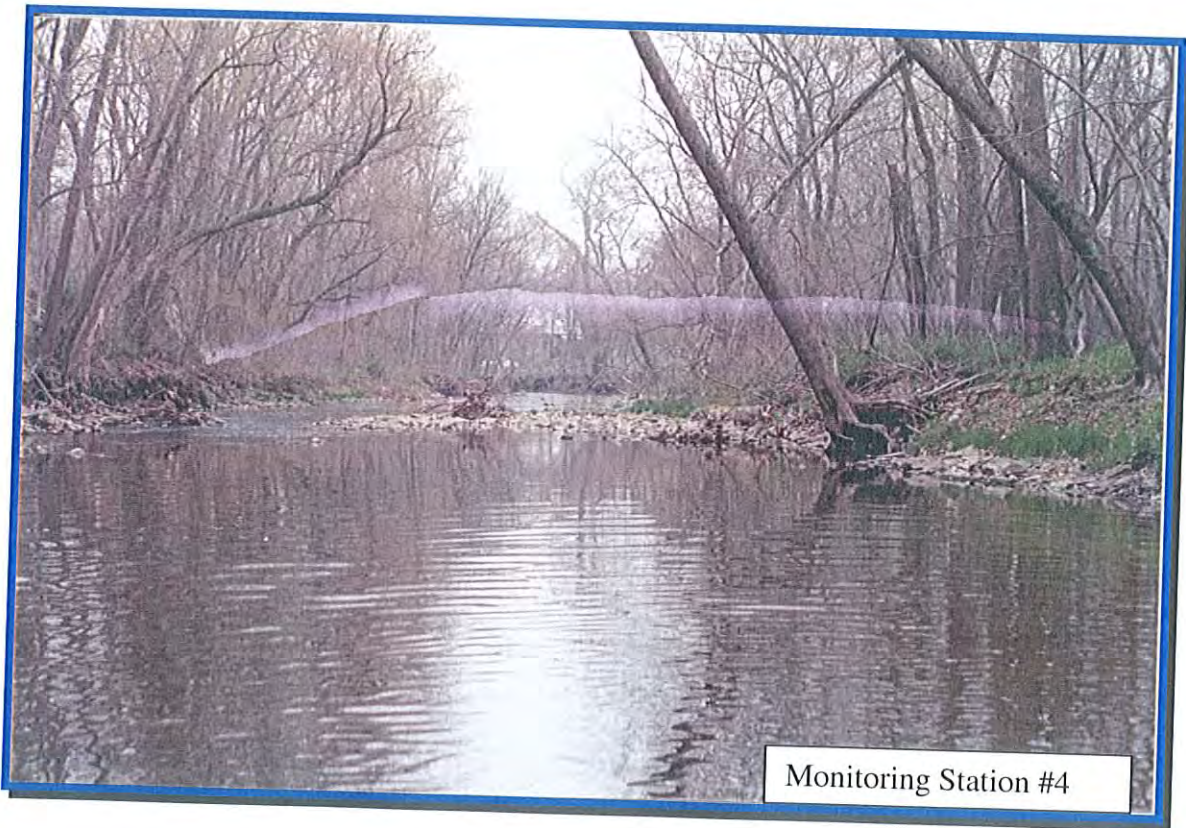
Monitoring Station #4

Monitoring station # 4 is located on the Main Stem at the confluence with the West Branch. This station is located in a very scenic forested valley. Because of its undisturbed, natural stream channel and riparian zone condition, this location should be thought of and used as a reference and/or model for future restoration endeavors in the lower half of the Main Stem. This station exhibits all the “good things” one strives to restore when going about improvement projects – forest buffer, in-stream cover, stable streambanks, sediment free substrate, riffle and pool habitats.

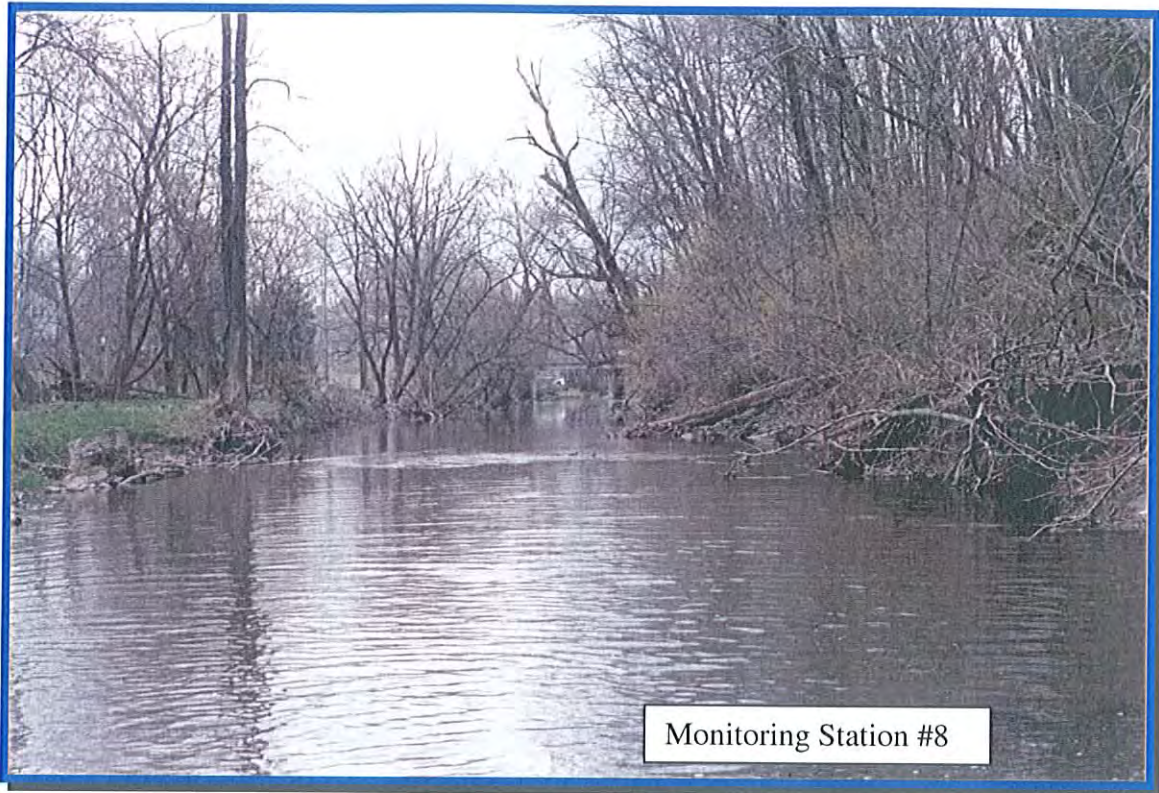
Monitoring station #7 is located in the West Branch headwaters immediately downstream of Route 464 "Columbia Avenue". This area is highly developed, consisting of commercial and residential landuse. This section of stream ranked rather low in all habitat categories. Stormwater from Columbia Avenue and the surrounding developed area certainly influences water quality in this location. A considerable amount of litter was observed in the stream in this location, as well as dump lawn clippings from area residents.

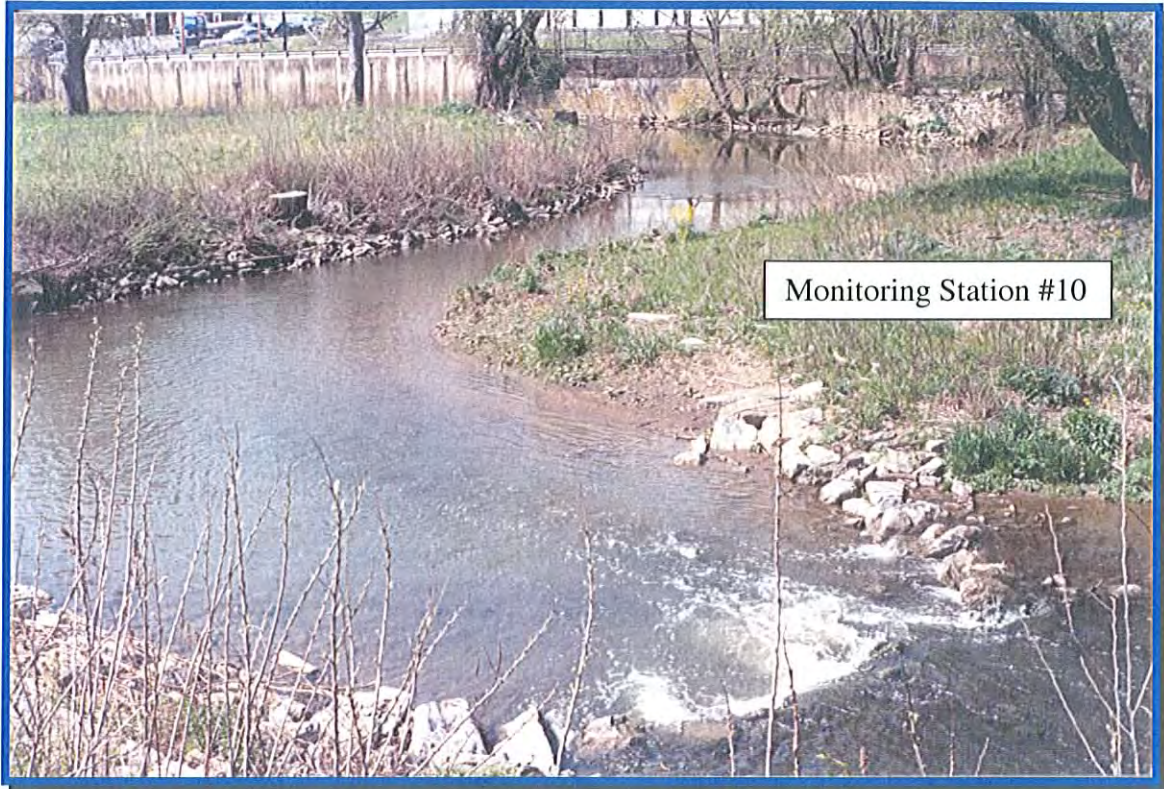
Monitoring station #9 is located on the Main Stem in Manor Park just downstream and south of Charlestown Road. Much of the stream in this area is immediately bordered by mowed lawn. Only a few larger trees line the streambank, native shrubs and other herbaceous plants are rare. Obviously the forest buffer in this area could be much improved. In-stream cover was adequate for smaller fish, but larger cover structure for larger fish such as Smallmouth bass was limited.

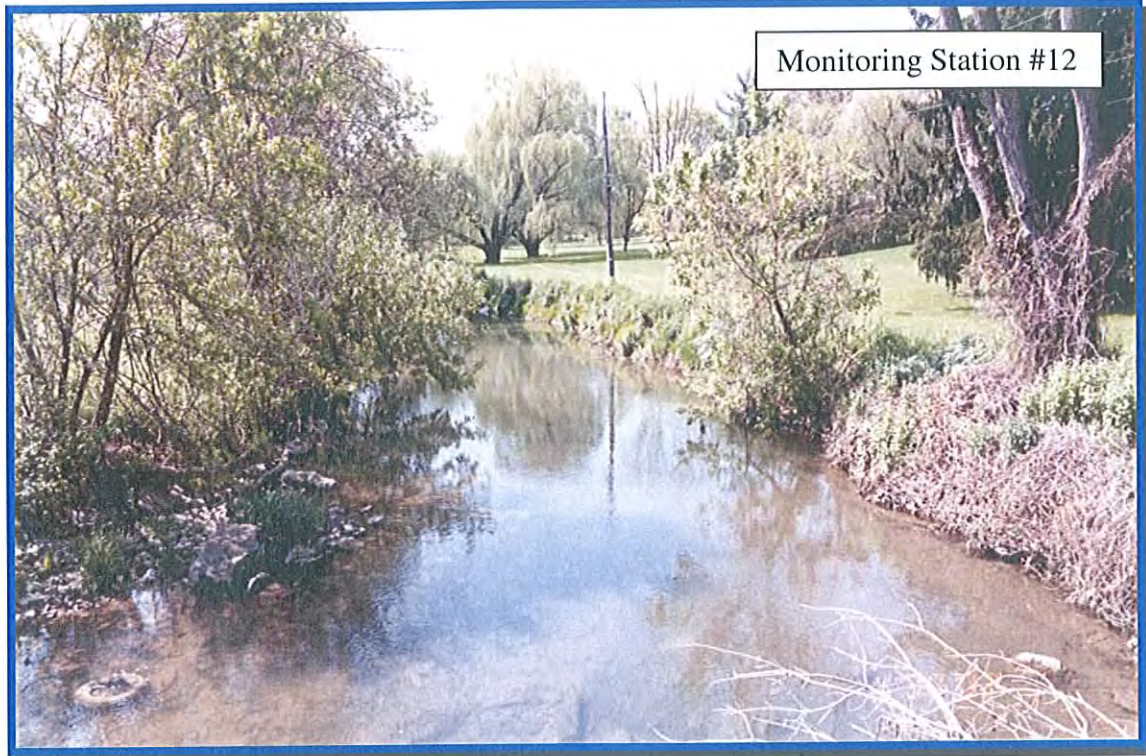
Monitoring station #11 is located on Brubaker Run within a park owned by East Hempfield Township approximately 1,300-feet upstream from the confluence with the Main Stem. This reach of stream is surrounded by a healthy forest buffer and for the most part is in a wooded setting. Brubaker Run, although a smaller stream, exhibits good habitat features in this location. Such is not the case further upstream where Brubaker Run is surrounded by commercial landuse.

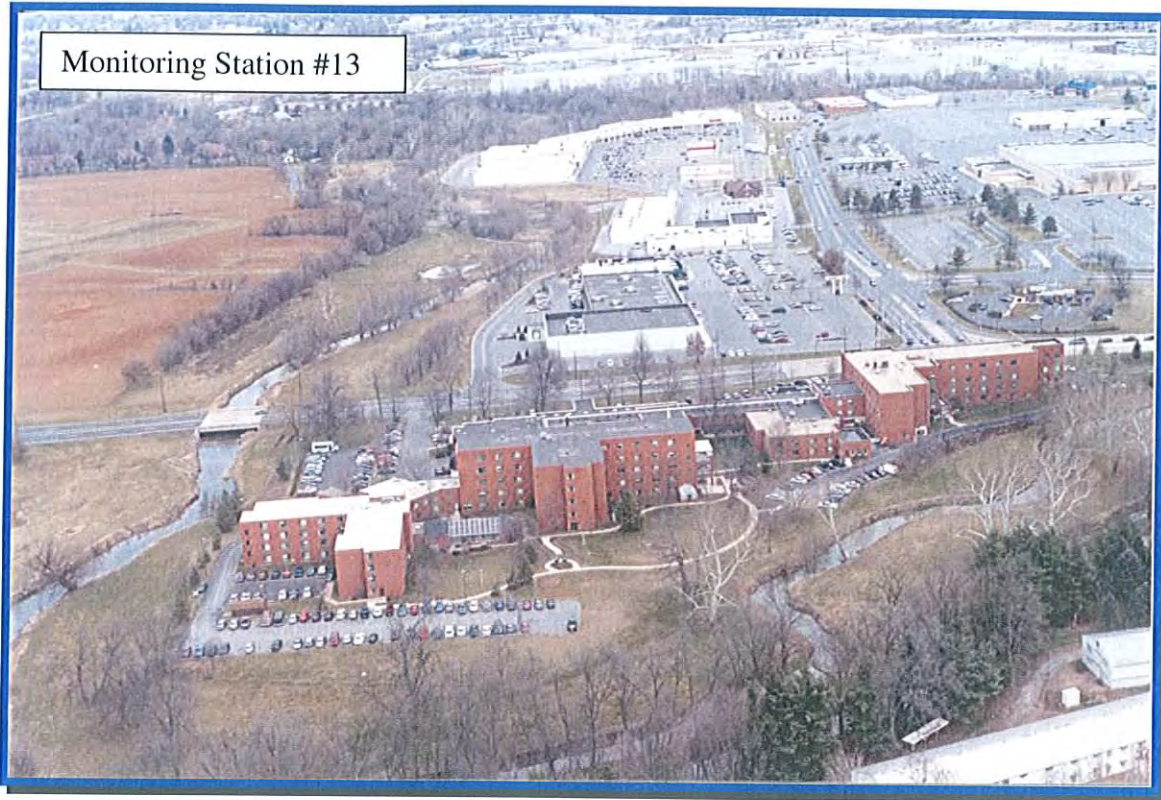
Monitoring station #12 is located on the Main Stem immediately downstream of Route 23 “Marietta Pike”. This section of stream is located in a residential setting where backyard lawns encroach right up to the top of the streambank, offering little in the way of forest buffer and riparian habitat. Habitat under the water and within the channel isn’t any better. Much of the substrate is sediment laden and little overhead cover exists for larger fish.

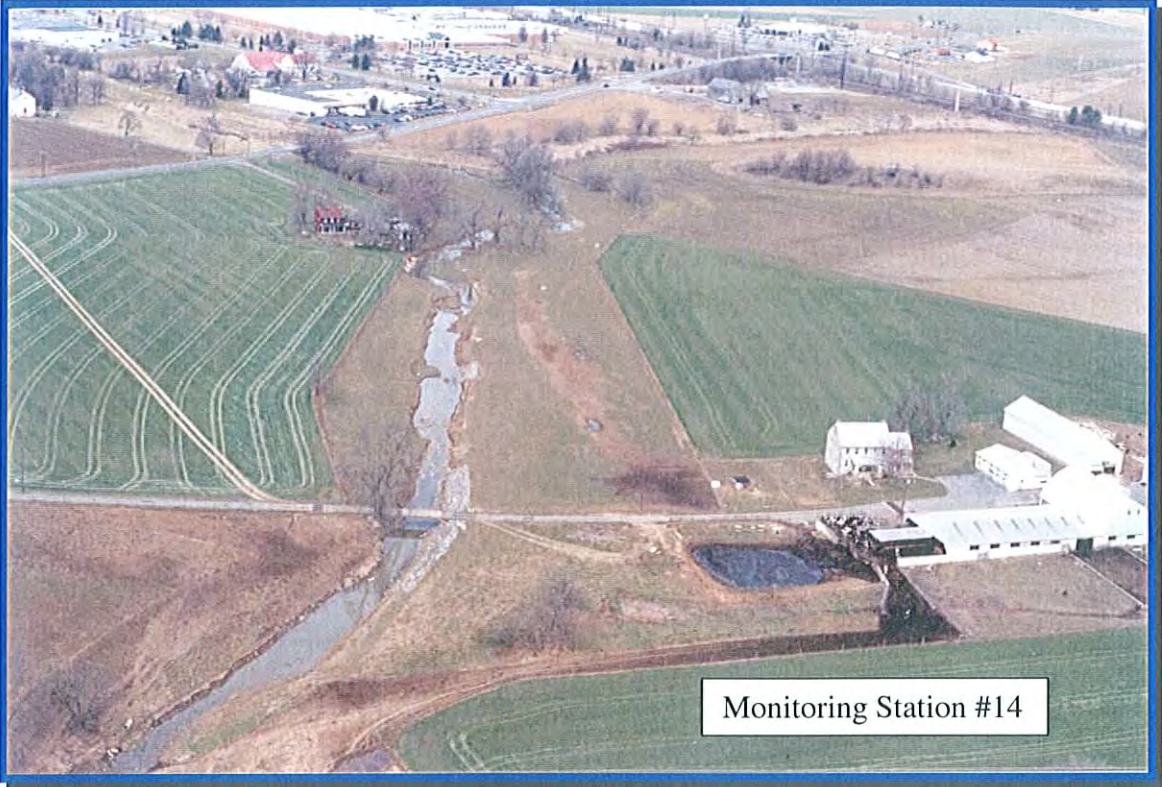
Monitoring Station #14

The worst monitoring station in regards to habitat quality was station #14 located immediately downstream of State Road in East Hempfield Township. Station #14 is located in a pasture where dairy heifers have free access to Swarr Run. The pastureland is severely overgrazed and streambank erosion is excessive. Swarr Run's substrate in this local is sediment-laden and severely trampled by wading livestock. No other single farm within the entire Little Conestoga Creek Watershed exhibited such an overwhelming abuse of the stream and riparian zone. Other farms have "hot spots", like a small feed lot or exercise lot, but no other single farm impacts over one-half mile of stream corridor!

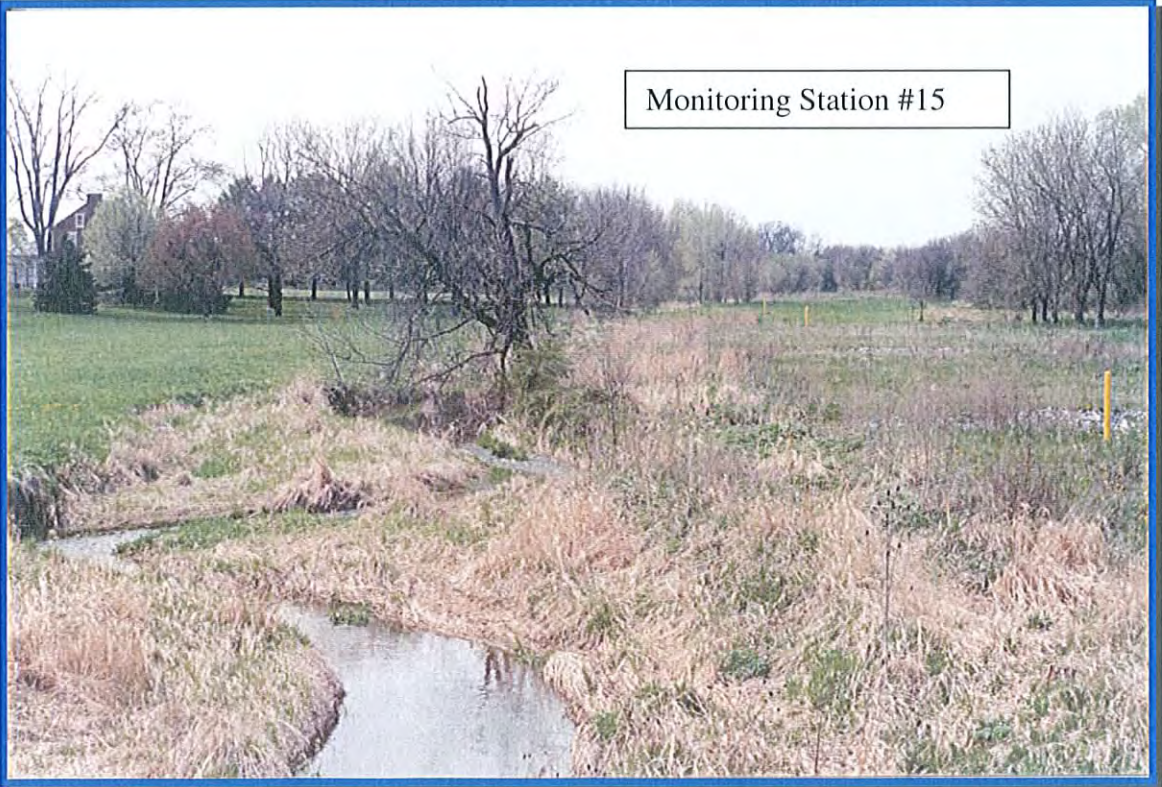
Monitoring Station #15

Ironically, the best monitoring station in regards to habitat quality was monitoring station #15 located upstream of State Road and station #14. The difference between stations #14 and #15 is dramatic; with channel width being the most apparent difference. The un-trampled stream channel at station #15 is less than half the width of the trampled stream channel at station #14. Station #15 is located in a sheep pasture that fortunately is not overgrazed. The stream isn't bordered by many trees and shrubs, but a good stand of filtering grasses and other herbaceous plants line the streambanks. The streambanks are stable and do not show signs of accelerated erosion, though they are undercut in some locations providing excellent overhead cover for fish. The substrate in the riffle areas is fairly void of sediment.

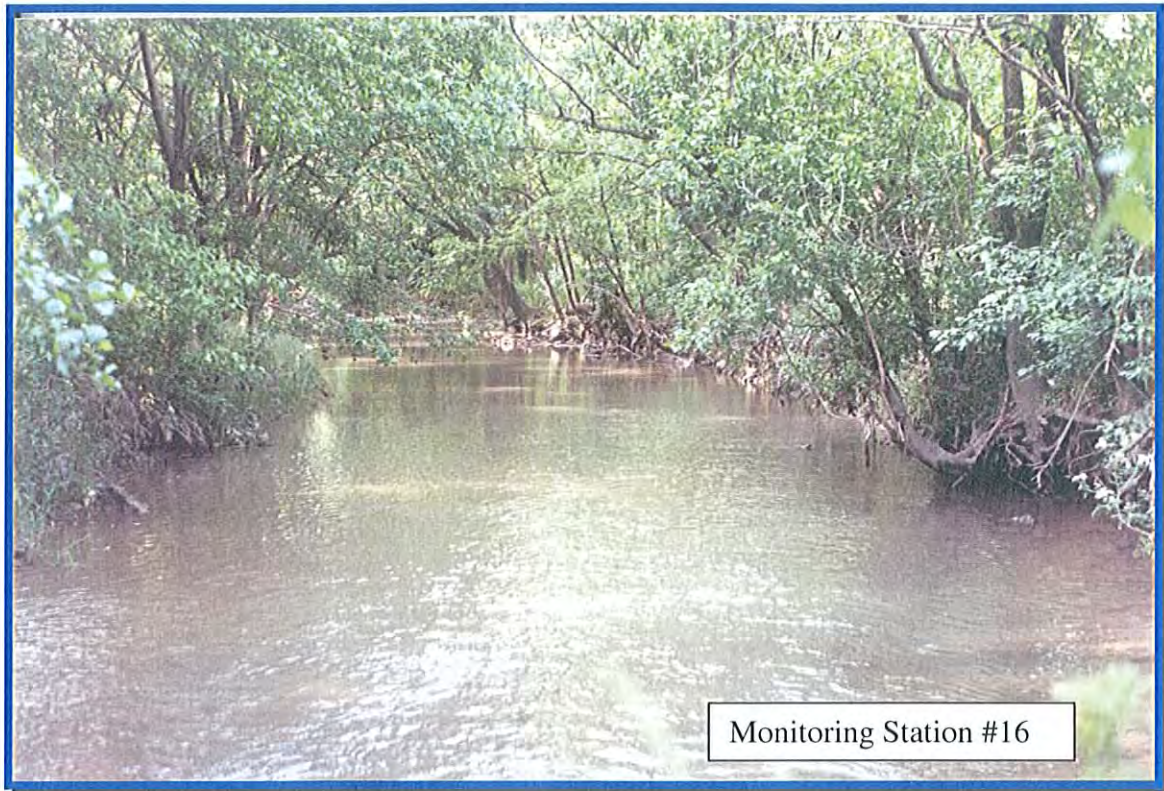
Monitoring station #16 is located on the Main Stem just downstream from Flory's Mill south of Route 283. Below Flory's Mill, the stream channel is unaltered and flows through a forested area whereas at Flory's Mill, the stream is artificially channeled and actually flows under a portion of the old mill building. Station #16 had suitable in-stream habitat for larger fish and is a popular stocked trout fishing location.

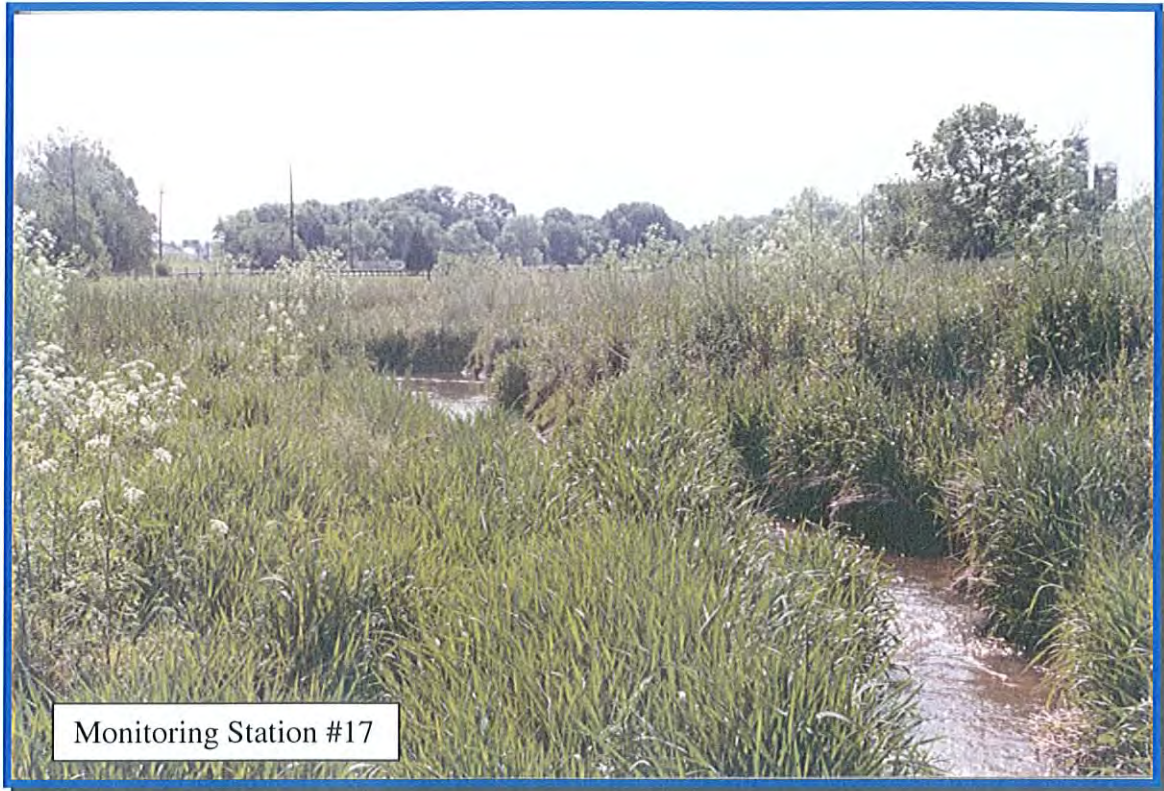
Monitoring station #17 is located on a small un-named tributary just south of Route 283 on the Kolb Farm. The un-named tributary enters the Main Stem just below Flory's Mill. In 1997, students from the Lancaster County Academy installed streambank fencing and planted trees and shrubs along this pastured section of stream. The pasture had previously been overgrazed and streambank erosion due to excessive cattle trampling resulted. Since the fencing project, the stream has shown signs of recovery. The streambanks are re-vegetated and the channel is being to narrow and deepen. This section of stream should improve as the planted forest buffer matures and the stream purges itself of its previous sediment load.

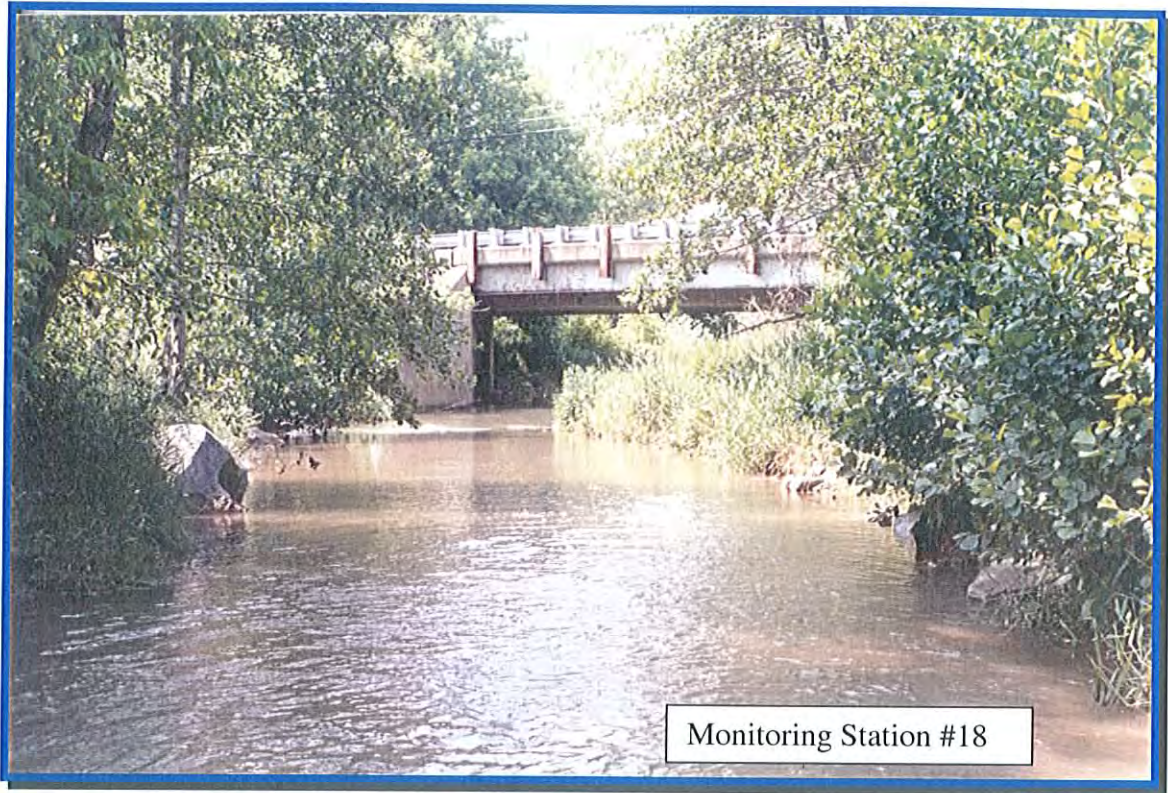
Monitoring station #18 is located on the Main Stem on property owned by PPL just north of Route 72 “Manheim Pike”. In 1997, PPL completed a stream restoration project involving a forest buffer planting and installation of in-stream channel stability controls designed by consulting firm LandStudies of Lititz, Pennsylvania. This section of stream is recovering quite nicely. The various channel stability controls (rock weirs, cross-vanes and root wads) seem to be functioning properly, providing both stability and riffle/pool habitats for fish. The Little Conestoga Watershed Alliance should consider this restoration work a prime example of properly designed and installed in-stream channel stability control measures.

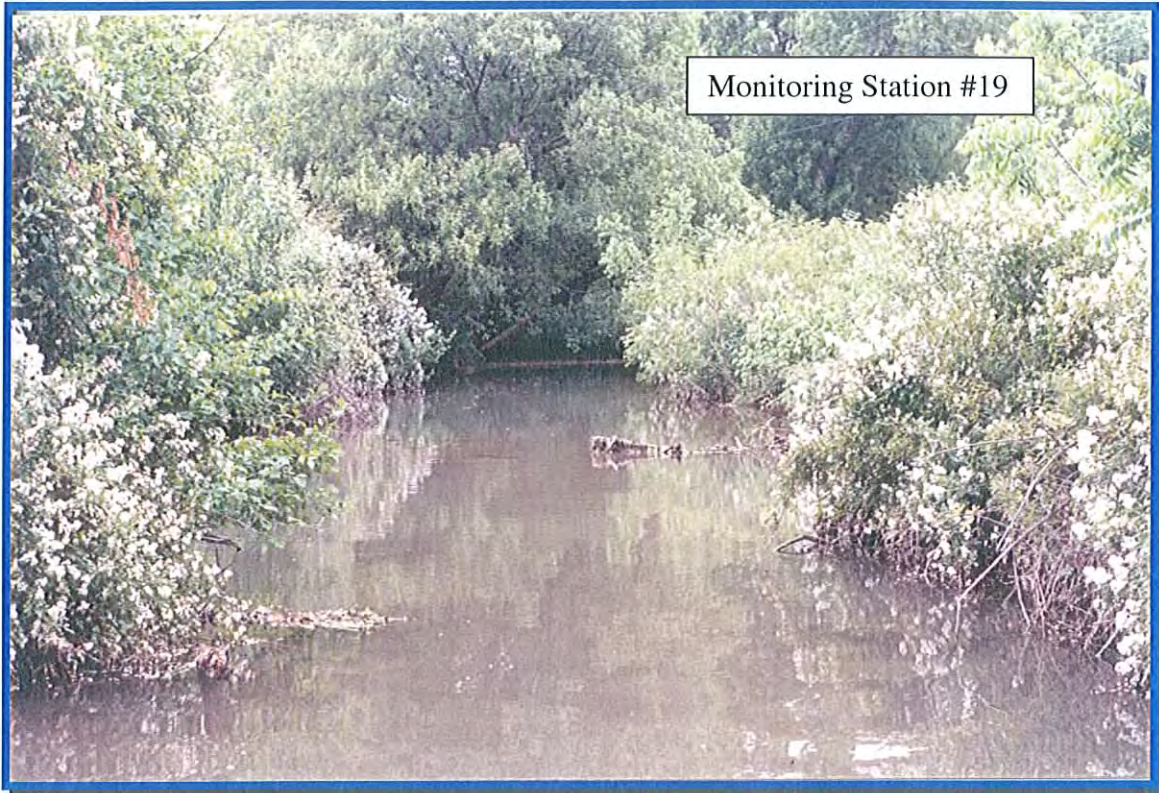
Monitoring station #19 is located on the Main Stem just above Miller Road east of East Petersburg Borough. This area shows great promise for a future trout fishery. In-stream cover for fish is excellent. Much of the immediate upstream area is wooded and/or fallow. The area also contains several springs that serve to recharge the stream and steady cool water temperatures.

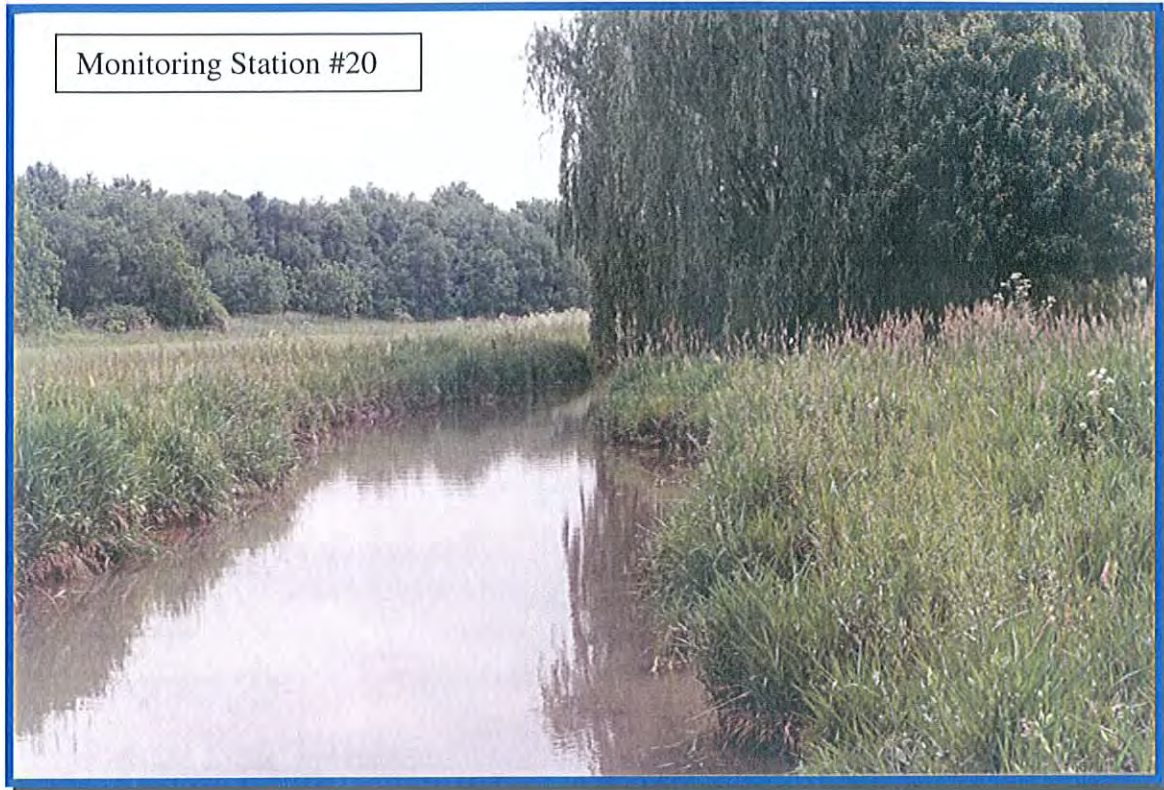
Monitoring station #20 is located on Bachman Run immediately upstream of Fruitville Pike in the Wetherburn residential development. Currently this reach of stream is in poor condition. The substrate is heavily sediment laden. Little exists in the way of a forest buffer, only a few trees in backyard lawns line the eastern bank. Much of the eastern streambank from Fruitville Pike upstream to Route 772 "Petersburg Road" (a distance of approximately 2,300-feet) is grass lawn. A crop field that is usually planted in either corn or soybeans, but is slated for residential development in the near future borders the western bank. The Little Conestoga Watershed Alliance has received a Growing Greener Grant in the amount of \$52,125.00 to restore Bachman Run more-or-less from Fruitville Pike upstream to Route 772 "Petersburg Road". Residents of Wetherburn and developer Barry Hogan are supportive of the restoration project.

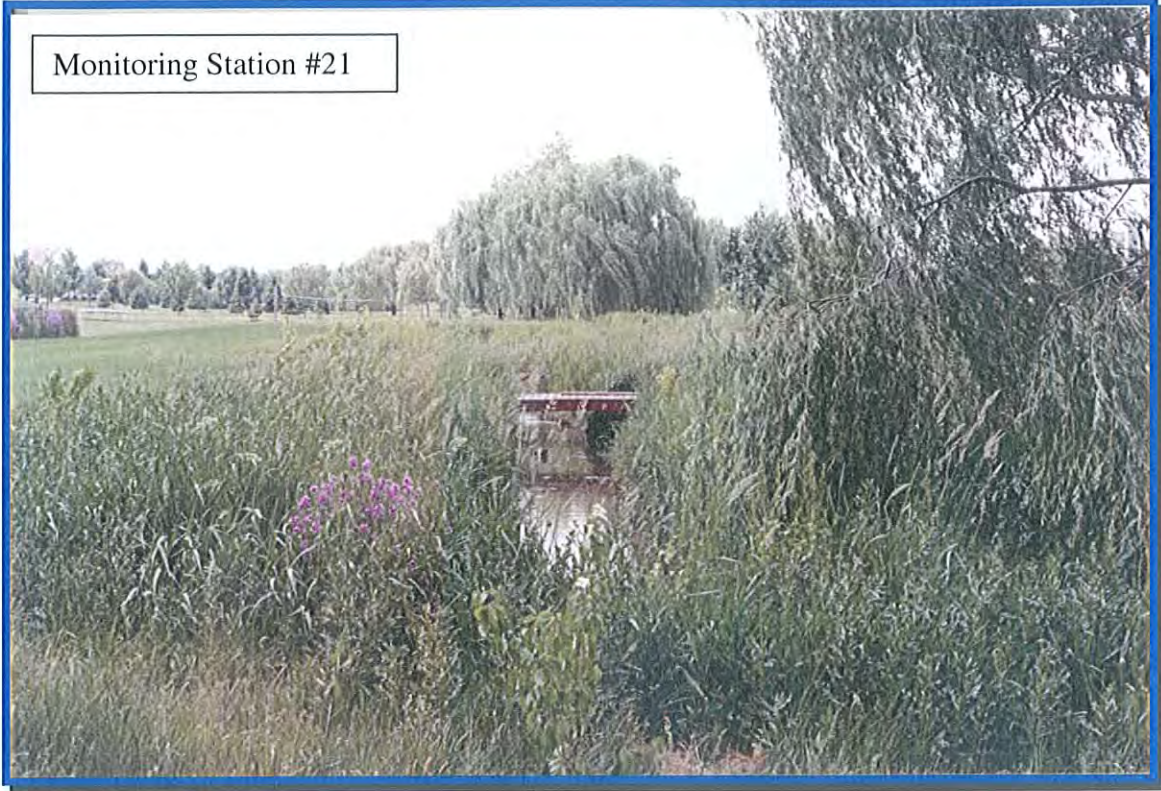
Monitoring Station #21

Monitoring station #21 is located on Bachman Run just north and upstream of Koser Road in the Wetherburn North development. In the spring and summer of 2002, Donegal Trout Unlimited and Little Conestoga Watershed Alliance members planted various trees and shrubs along this section of stream and established a good rapport with area residents. As was discussed earlier in this writing, the flow in this section of stream is heavily influenced by pumped water (or the lack of it) from Rohrer's Quarry located upstream. When the quarry pumps are running, the stream has plenty of flow and offers adequate cover and suitable habitat for fish. However when the pumps are off, the water nearly vanishes from the stream channel during the summer months, making the stream an unsuitable habitat for fish. Upstream sink holes and East Petersburg's drawing of water from a municipal well also likely play a role in the fluctuation of baseflow volume. This entire situation deserves closer attention and investigation.

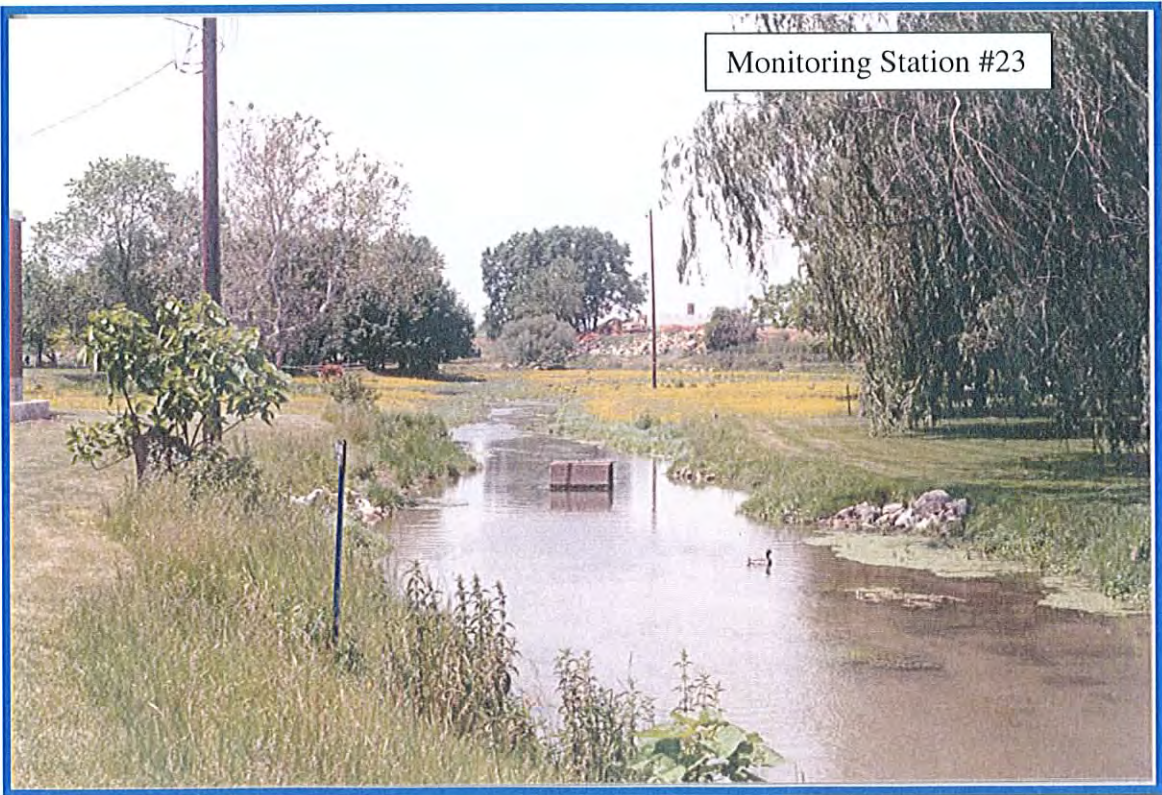
Monitoring Station #23

Monitoring station #23 is located in the headwaters of the Main Stem at Route 772 “Petersburg Road/Graystone Road”. Downstream of Route 772, habitat conditions are fair as the stream flows through following pastureland. Above Route 772, the stream is bordered on the west by East Petersburg Water Authority’s pump station and to the east by residential properties.

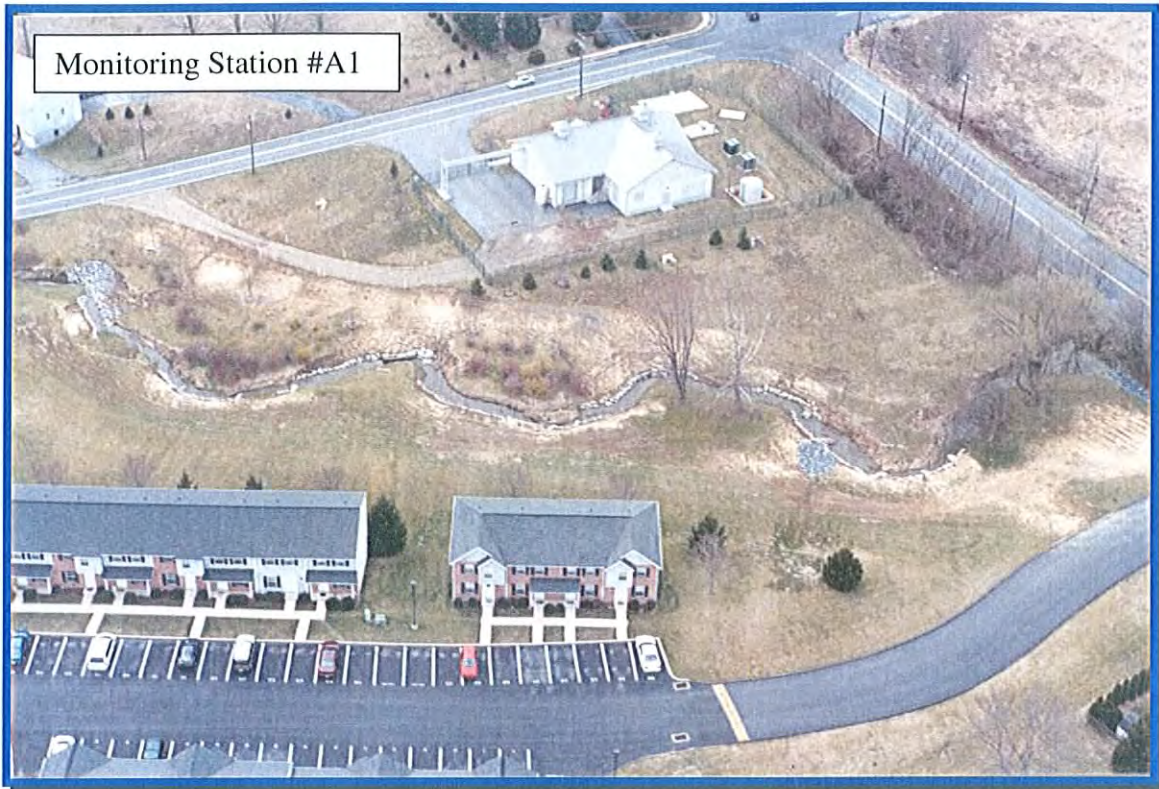
Monitoring station #A1 is located on an un-named tributary located just north of Charlestown Road in Manor Township. The above pictured section of stream (where station #A1 is located) was the site of a recent (spring 2002) stream restoration project by the Little Conestoga Watershed Alliance. RETTEW Associates, Inc. provided project design and construction oversight. This section of stream previously suffered from severe streambank erosion due to ill-managed stormwater and the encroachment of lawn mowers into the riparian zone. The restoration project included a forest buffer planting, bioengineering, and the installation of rock weirs, mud sills and boulder placements to provide channel stability and fish habitat. After one growing season and some rather intense storm events, all improvements seem to be doing fine.

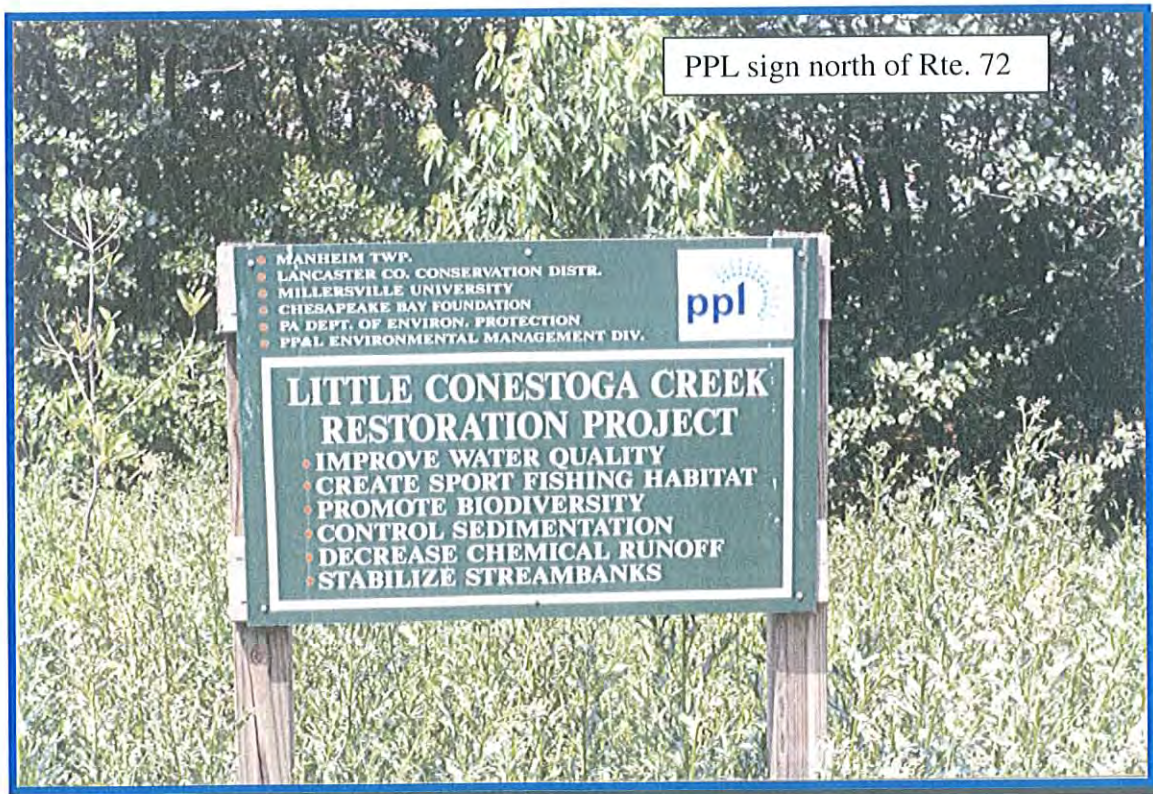
The earliest of these completed projects includes a 1997 streambank stabilization, fish habitat improvement and forest buffer planting and establishment on the Main Stem just upstream of Route 72 “Manheim Pike” on property owned by PPL. The project was design by Mark Gutshall of LandStudies, Lititz, Pennsylvania. The project is a fine example of some of the earliest “natural stream design” work completed in Lancaster County. Years later, this project is performing well and certainly can be deemed a success. PPL continues to do an excellent job maintaining the planted forest buffer and has established a “no mow” zone along the riparian corridor. Every spring, PPL sponsors a trout fishing derby that is a big hit with local youth anglers. PPL would make a great partner in the Little Conestoga Creek Alliance’s pursuit of stream restoration.
