# Little Conestoga Creek

## Watershed Assessment and Restoration Plan

January 2003

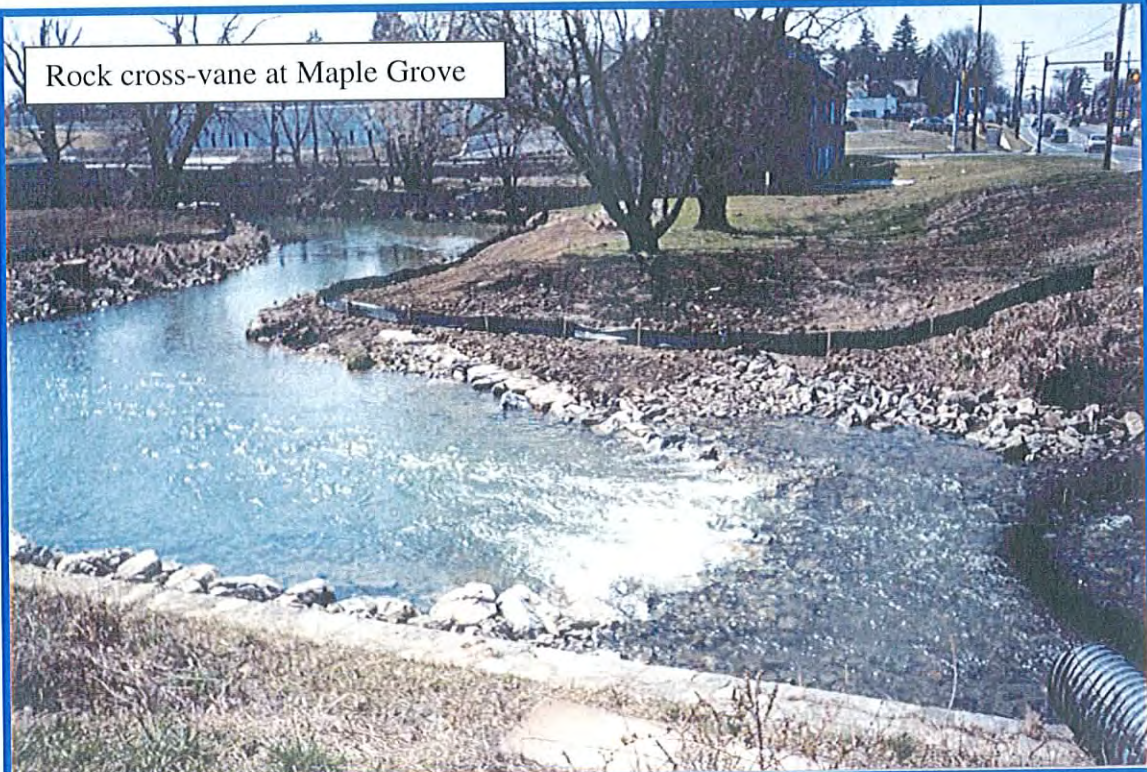
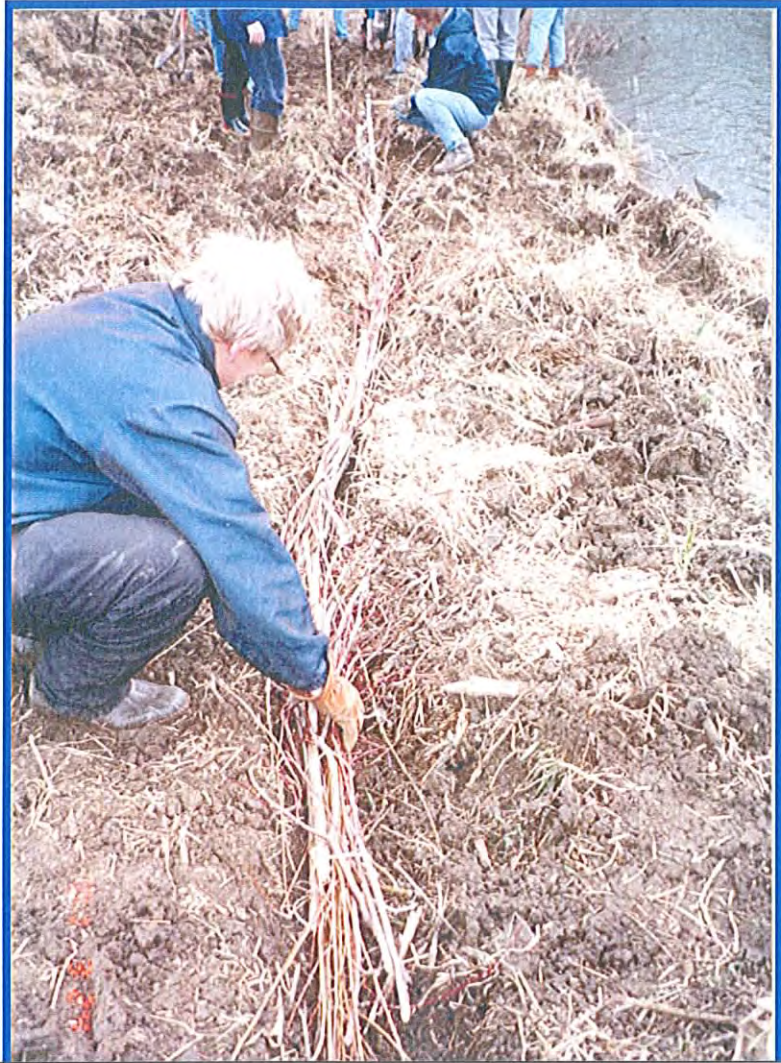
Fascine installation at Maple Grove – A “bioengineering” technique

The volunteers worked to address storm water runoff, soil erosion and sedimentation — problems that have increased because of recent land development. Repairing this section of the stream involved excavating floodway fills and depositions to increase floodwater storage capacity, re-grading and creating a buffer along eroded streambanks and installing rock vane and channel deflector structures for erosion prevention.
